NIST NCSTAR 2: Vol. I

Report of the Technical Investigation of The Station Nightclub Fire

June 2005

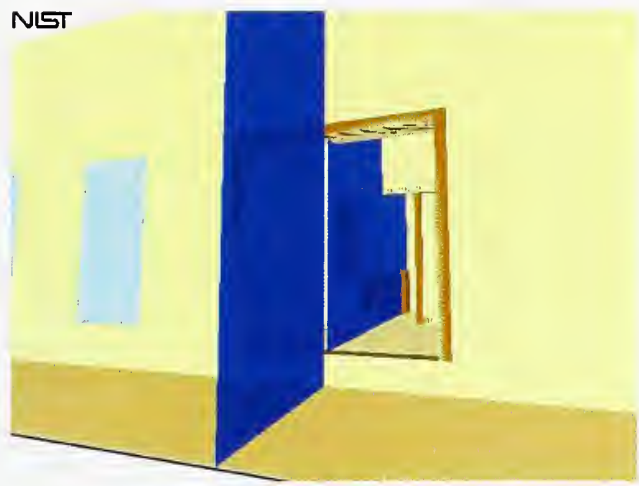
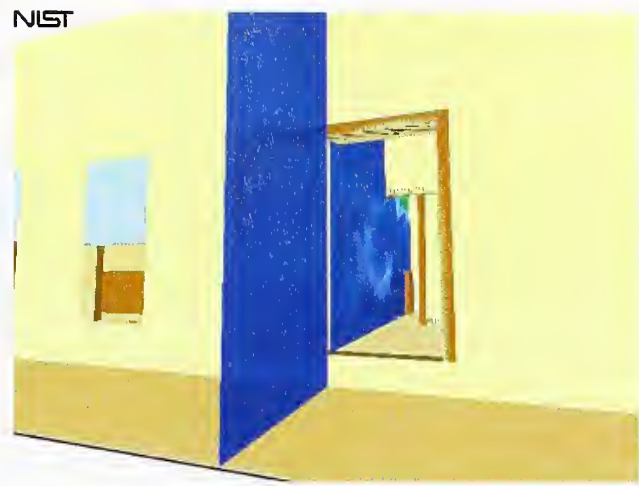
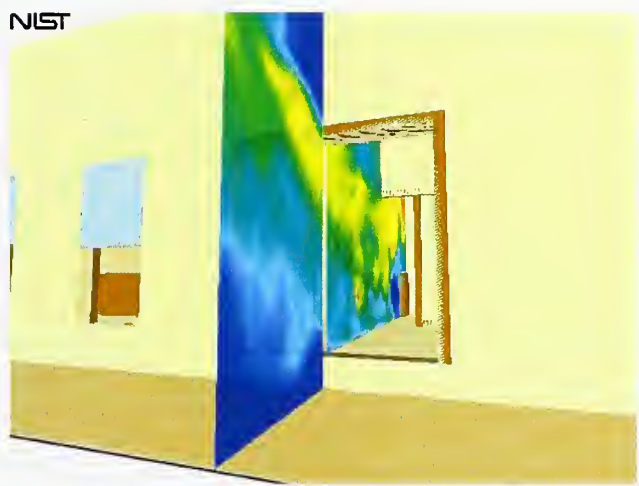
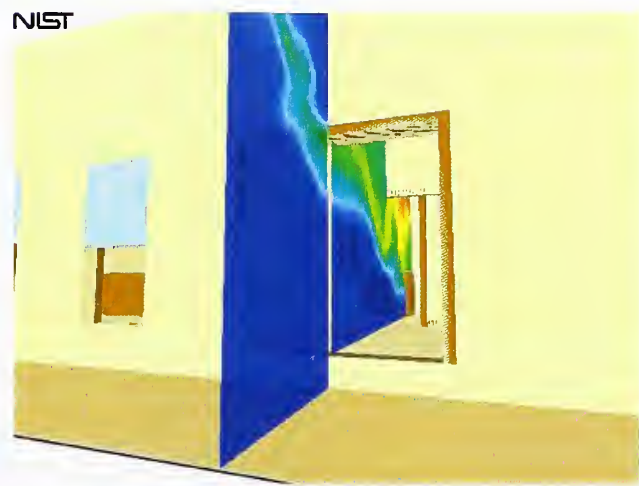
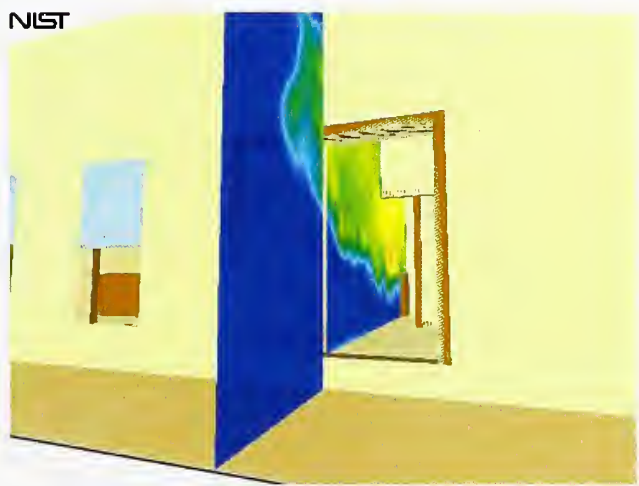
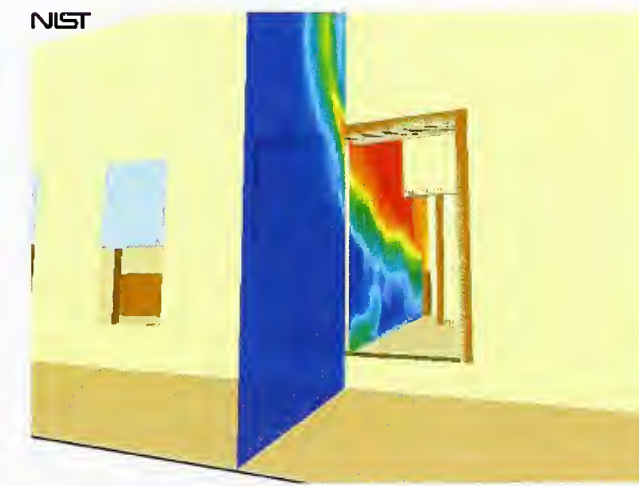
Figure 5-57. Temperature profile through the center of the entry foyer, 80 seconds to 250 seconds

Figure 5-57 shows the temperature predictions for the plane of data that is centered along the axis of the entry foyer. Temperatures just inside the front door, near the floor remain below the tenable limit because of the fresh air being drawn in through the doorway. This region of tenability decreases in a triangular orientation as the entranceway goes into the structure and gets smaller as the simulation continues. This simulation does not account for the occupants that accumulated in the doorway. Thirty-one victims were located in this area.

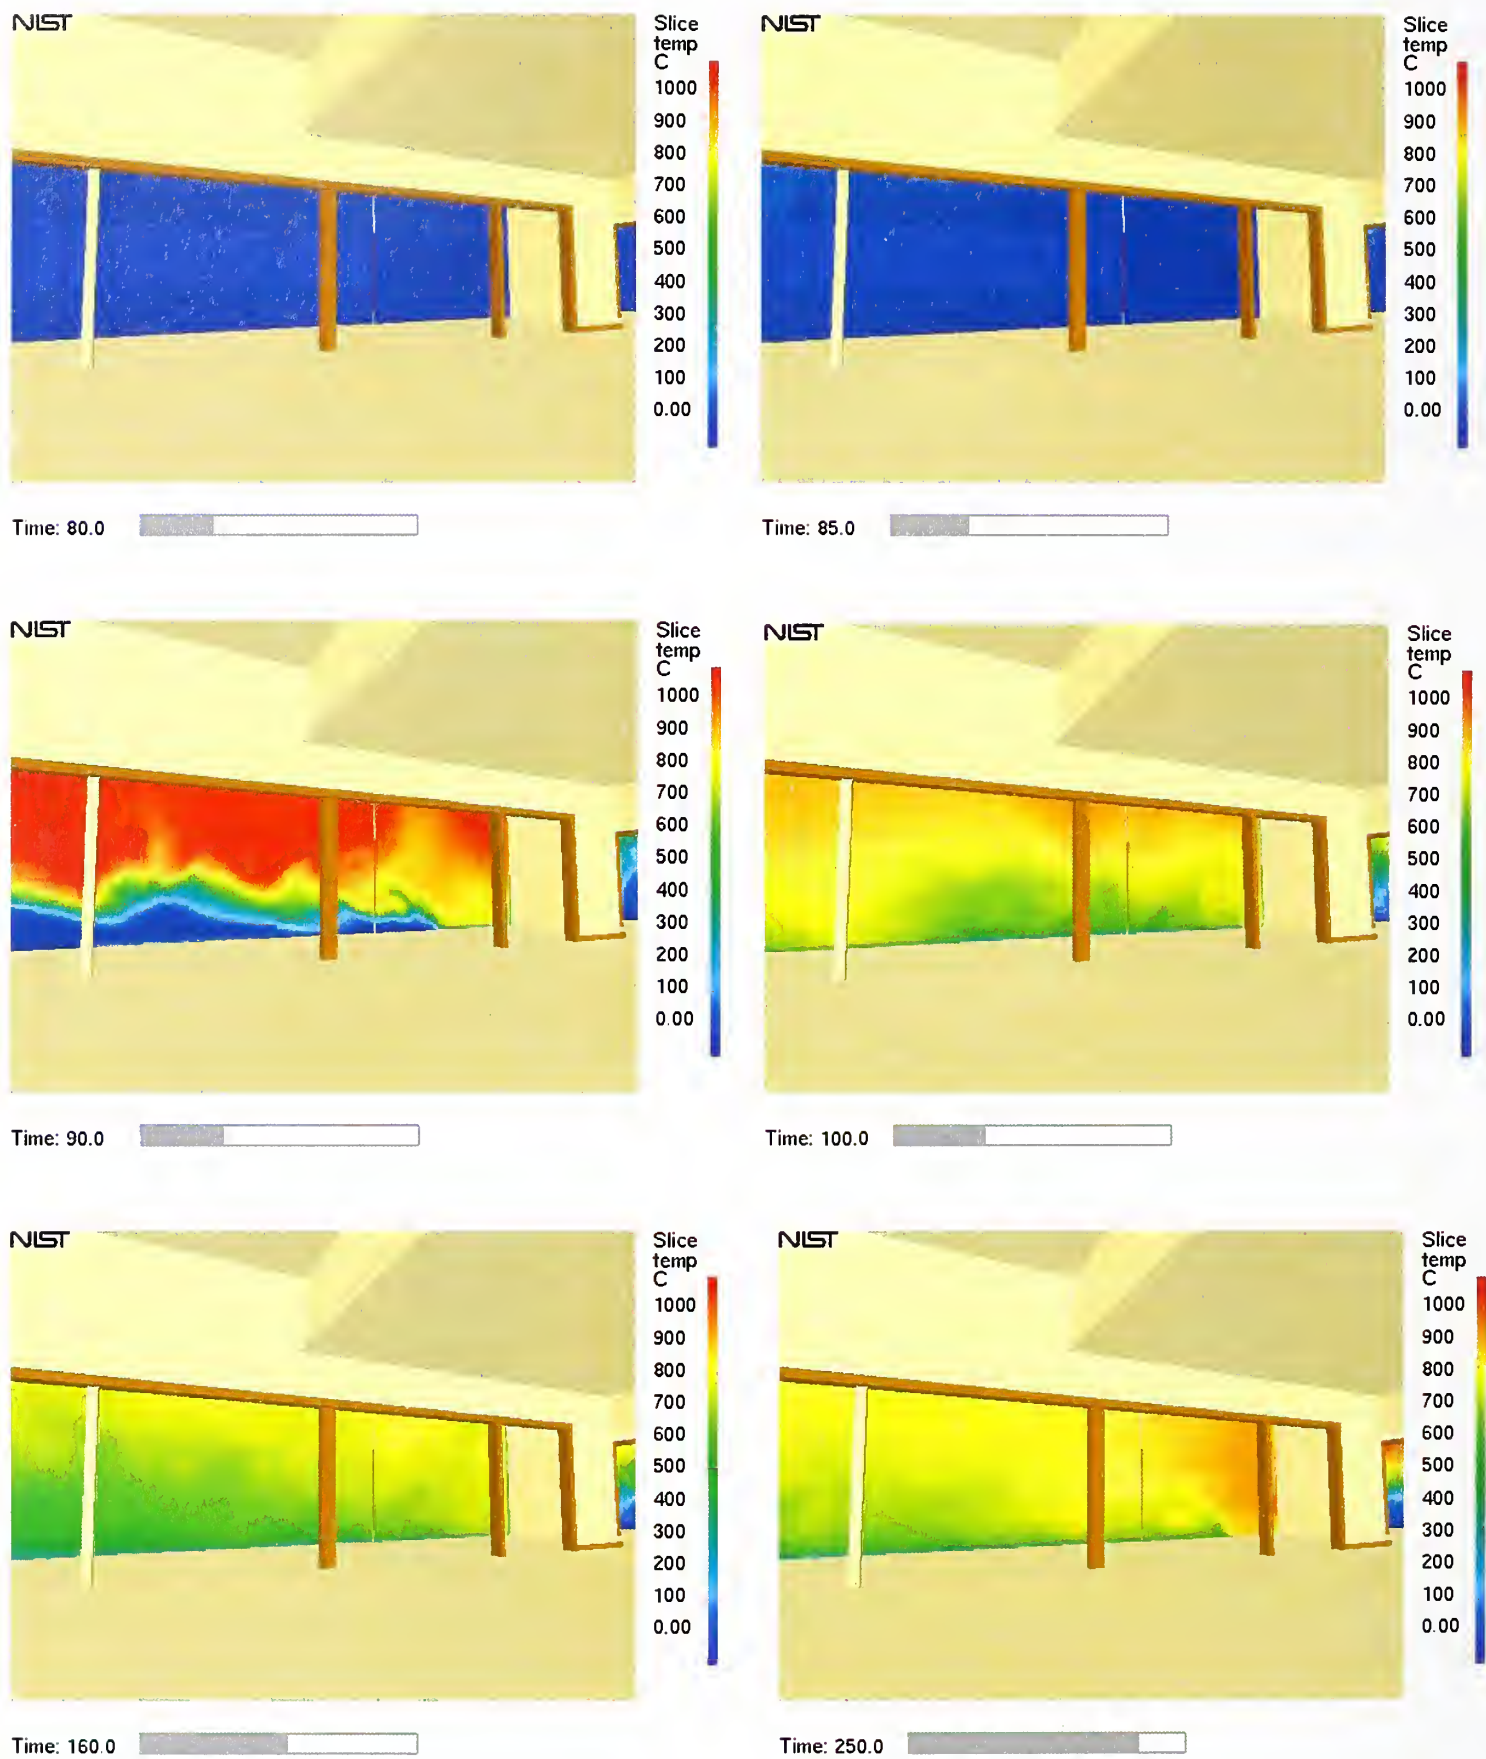
Figure 5-58. Temperature profile through the center of the sunroom, 80 seconds to 250 seconds

The area in the end of the sunroom adjacent to the entranceway was also a location that many victims were found. A vertical temperature slice through this area, shown Figures 5-58a and 5-58b, suggests that these victims did not have much time before the heat overcame them. Temperatures exceeded the 120 °C (248 °F) tenable threshold within 90 seconds after ignition. The simulation indicates that this change was rapid and extreme with temperatures in the upper portion of the space increasing from ambient conditions to flame temperatures on the order of 1000 °C (1830 °F) within 10 seconds. After the initial energy release due to the burning polyurethane foam (90 seconds), the predicted temperature decreased, but remained in the untenable range throughout the remainder of the simulation. Figure 5-58b shows that the temperatures increased again to 900 °C (1650 °F) at 250 seconds after ignition. The opening of portions of the bay windows between 78 seconds and 120 seconds after ignition had a minimal impact on reducing the temperatures in this part of the building. Eighteen victims were located in this area.

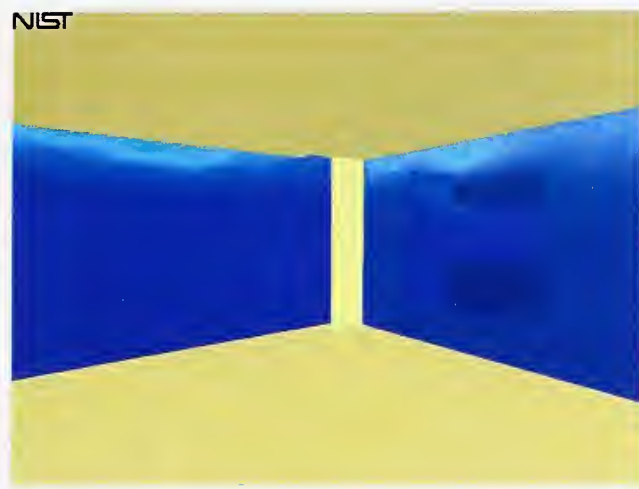
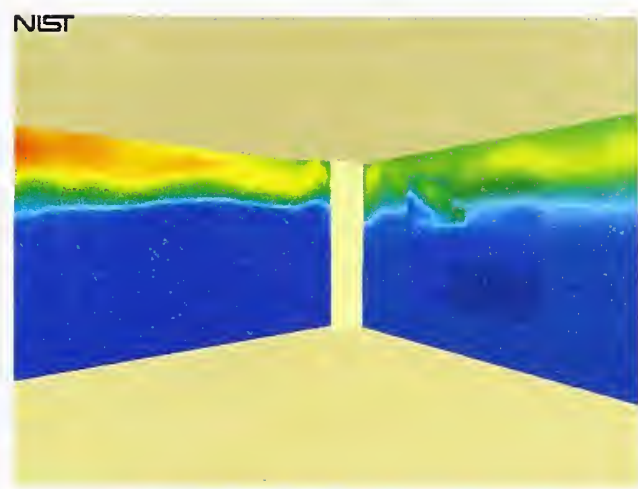
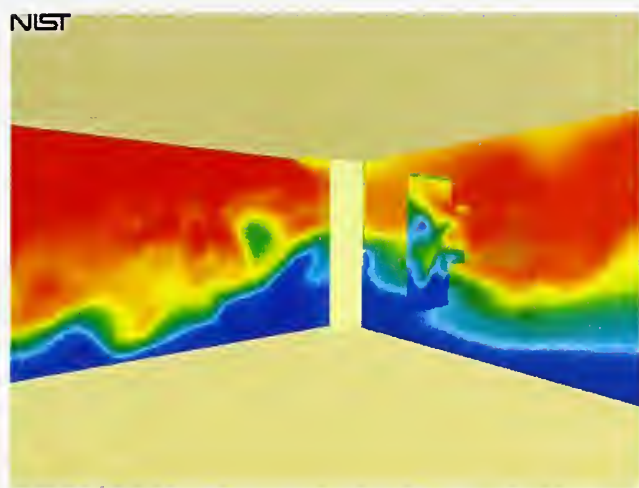
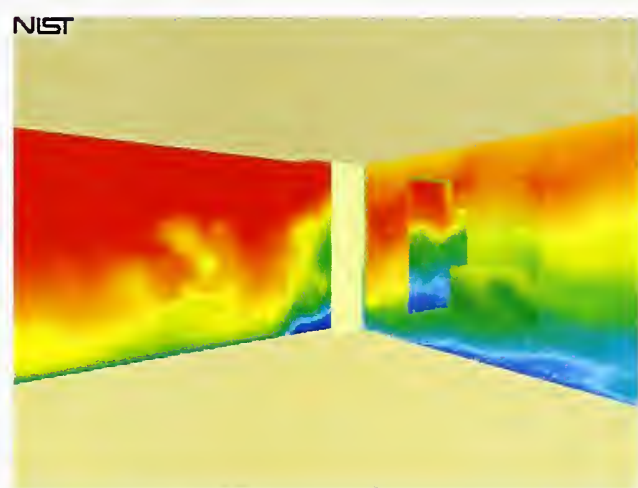
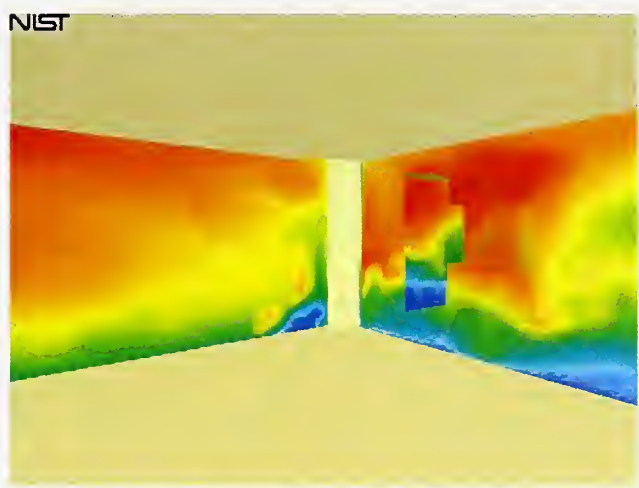
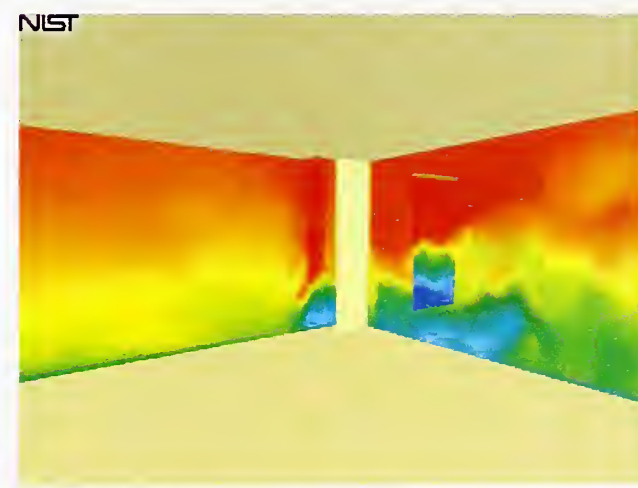
Figure 5-59. Temperature profiles approaching main entry foyer, 80 seconds to 250 seconds

Figure 5-59 depicts the temperatures in the approaches to the main entry foyer. The vertical temperature slices cover the area at the end of the entrance foyer and next to the ticket booth. The view is from the dance floor area looking toward the main entrance (front door). What appears to be a pillar in between the intersection of the two vertical slices is a portion of the wall that separates the sunroom from the main entry foyer. The images demonstrate that temperatures were untenable outside of the entranceway and that if the occupants were not able to make it into the area of cool air coming in from the front doorway, they did not have a chance of survival. Temperatures near the floor exceeded 400 °C (750 °F) within 100 seconds of ignition. Nine victims were located in this area.

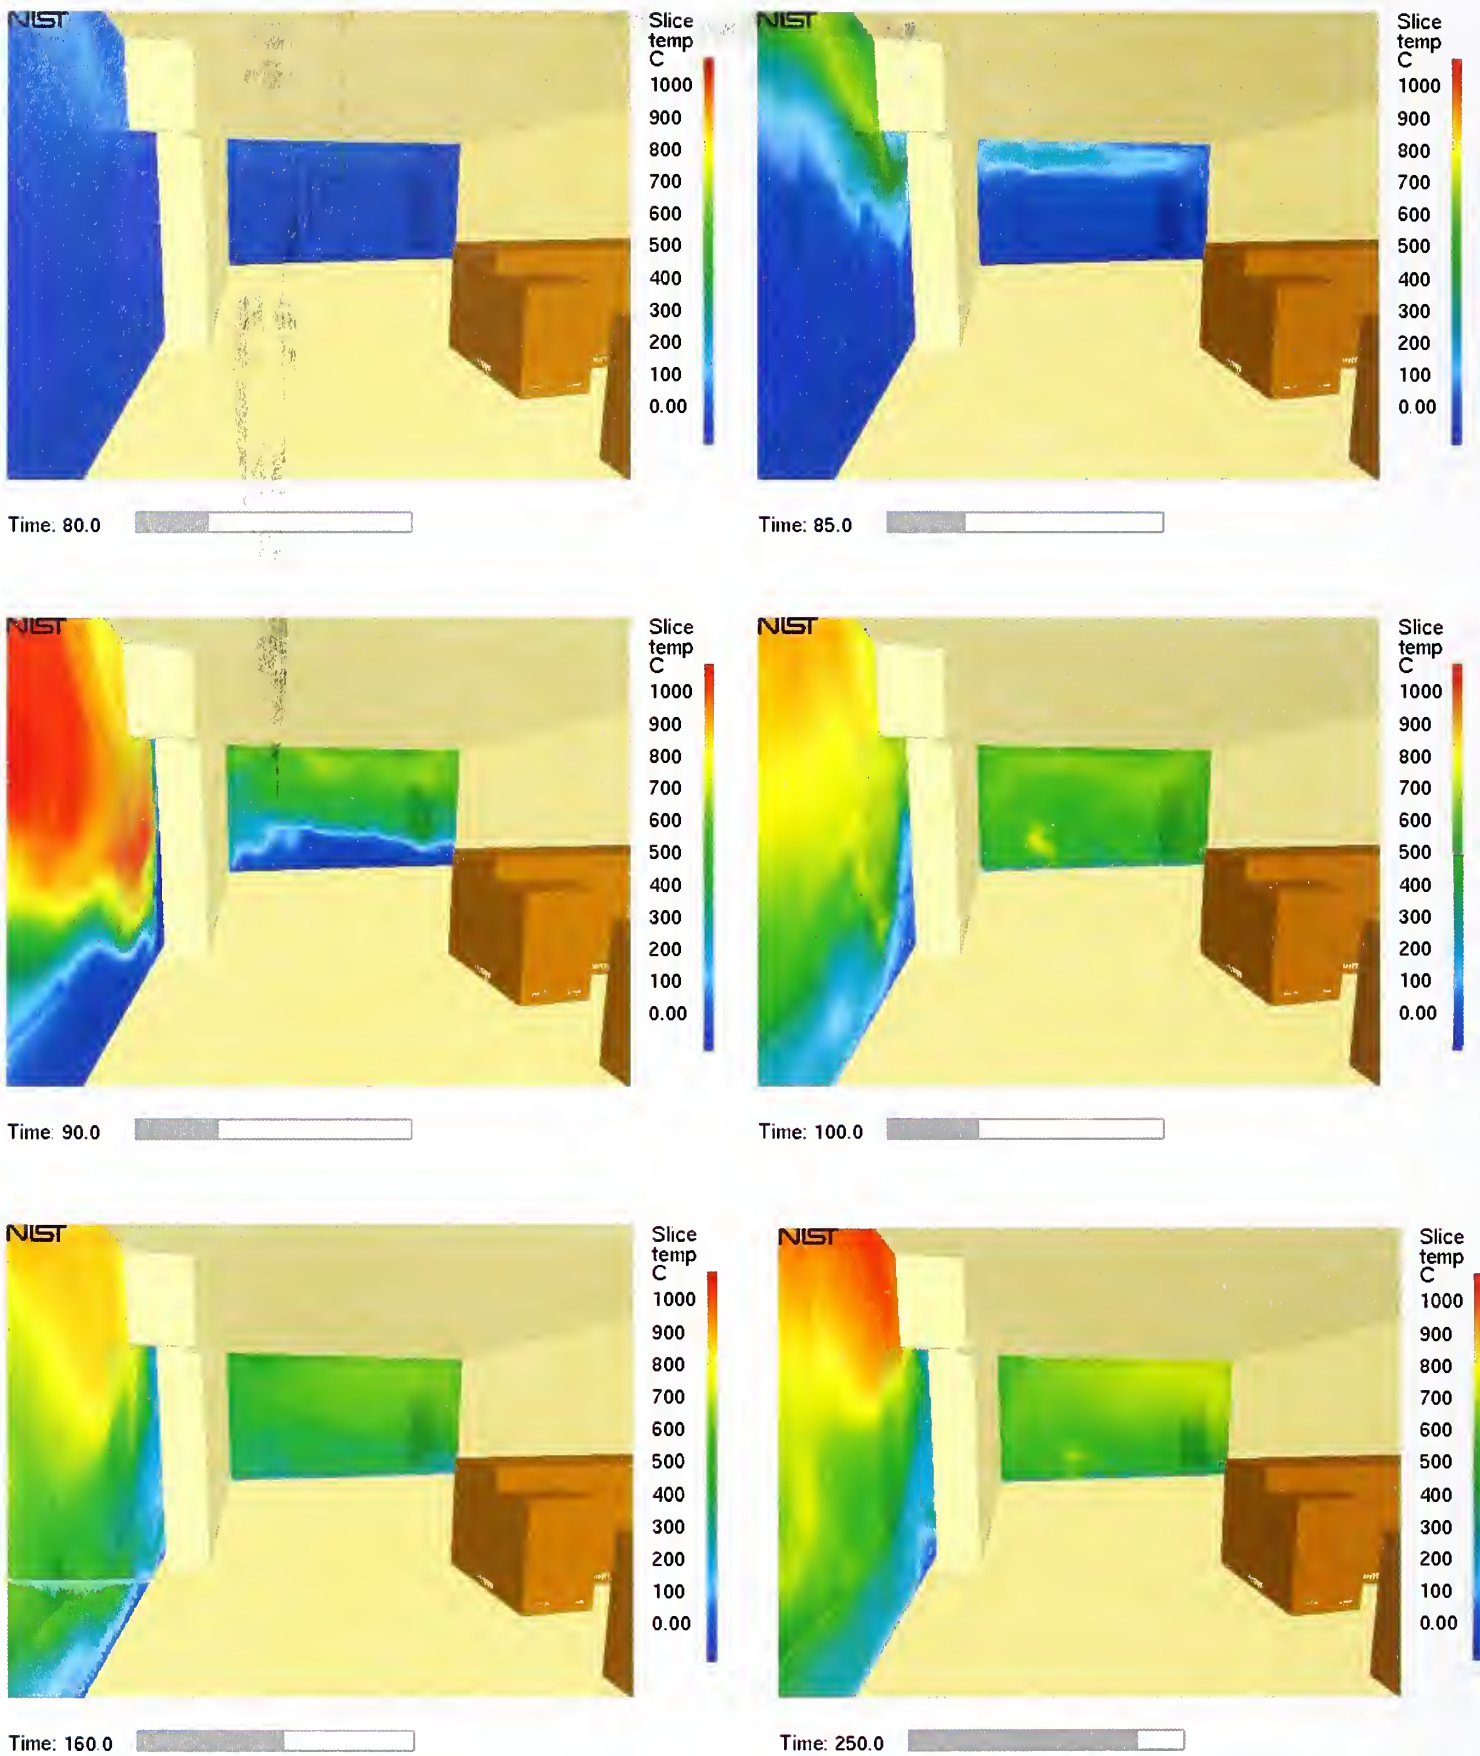
Figure 5-60. Temperature profiles in the dart room, 80 seconds to 250 seconds

The area of the nightclub with the side bar and the dart room is shown in the simulated images with vertical temperature slices bounding the area to the north (toward the main entrance) and to the east (toward the storage/office area entrance). Figure 5-60 shows the rapid change in thermal conditions between 80 seconds and 90 seconds after ignition. As in other parts of the nightclub simulation this significant increase in temperature was due to the burning of the polyurethane foam. Temperatures near the floor ranged from 200 °C (390 °F) to 600 °C (1110 °F) at 100 seconds. The figure indicates that the temperatures remained in the untenable range throughout the rest of the simulation. In the incident, nine victims were found in this area.

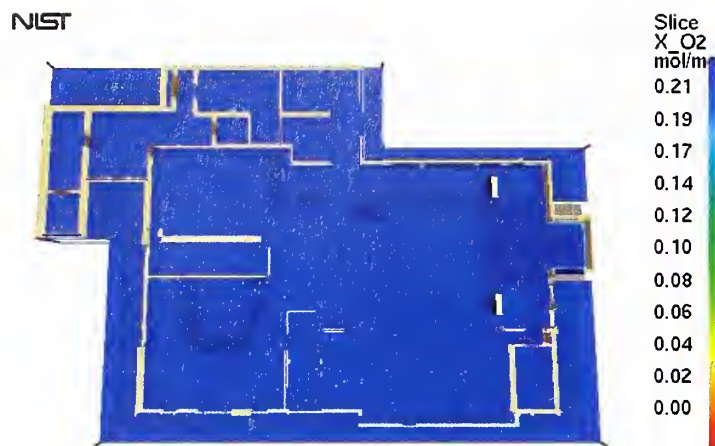
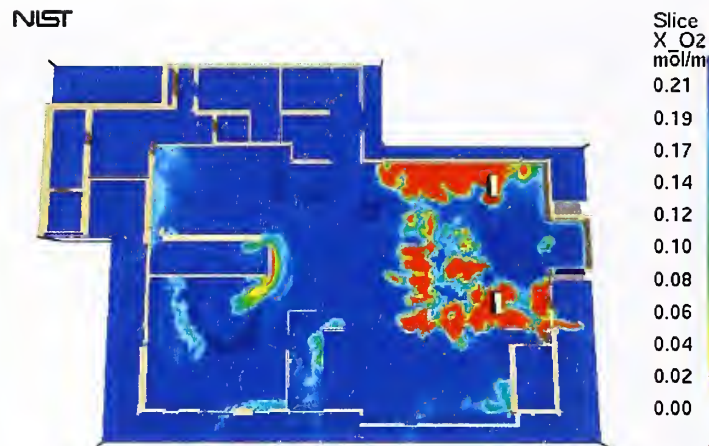
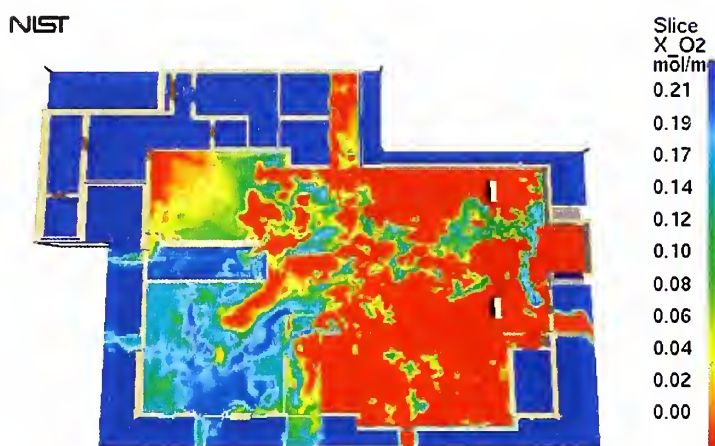
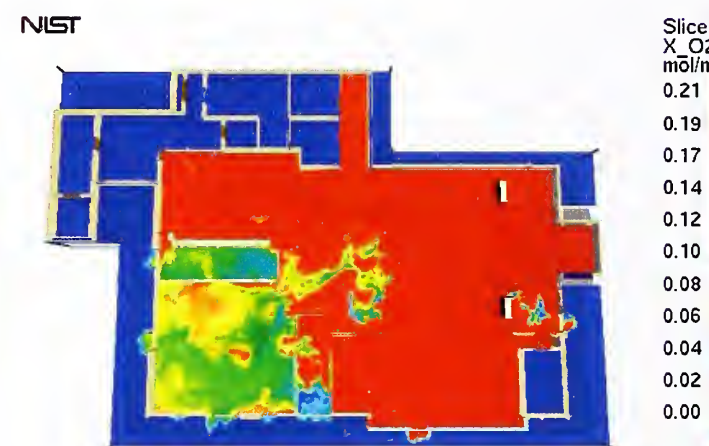
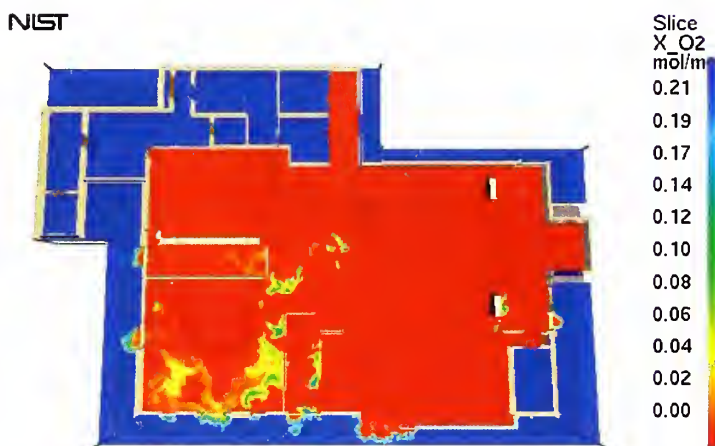
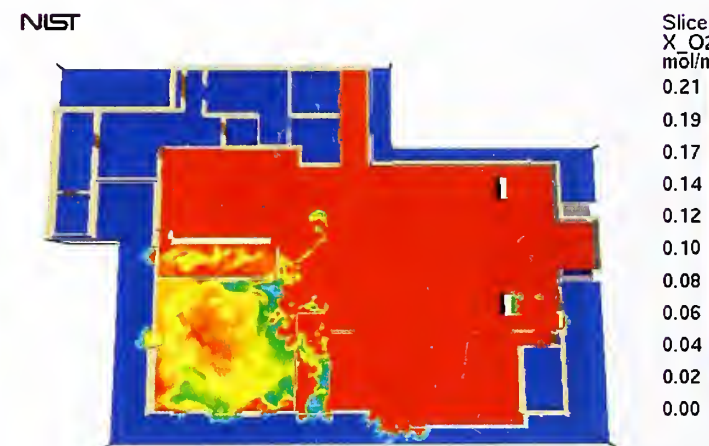
Figure 5-61. Oxygen volume fractions at 1.5 m (5 ft) above the floor, 80 seconds to 250 seconds

Just as the temperature levels rose rapidly after the platform area became fully involved in flames, the oxygen levels drop proportionally. As shown by the three dimensional smoke output in the previous section, the smoke spreads quickly through the structure. The first four images in Figure 5-61 range from 80 seconds after ignition to 100 seconds after ignition. This sequence has the most dramatic changes in oxygen concentration. Beyond 100 seconds the entire structure is untenable at the 1.5 m (5 ft) height. Tenability exists for the longest duration in the main bar area. Most of the building, including the platform and dance floor areas, the dart room, the main entry foyer and the main bar room, is shown by the simulation to be significantly depleted of oxygen to less than two percent.

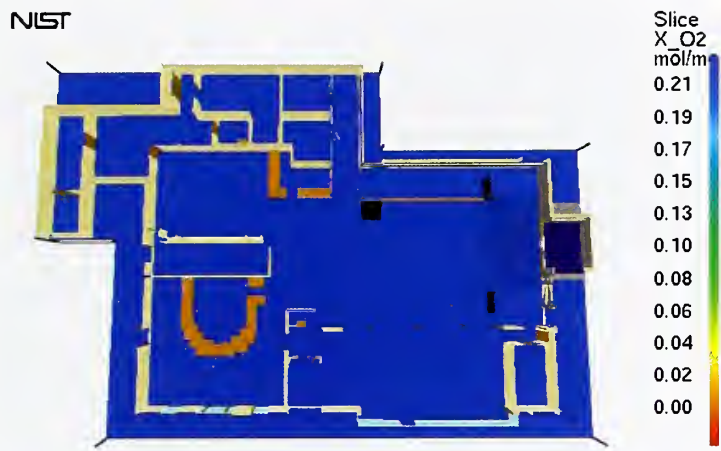
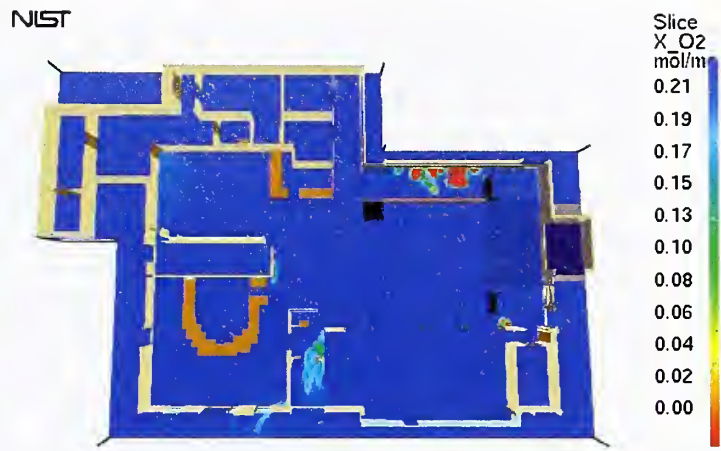
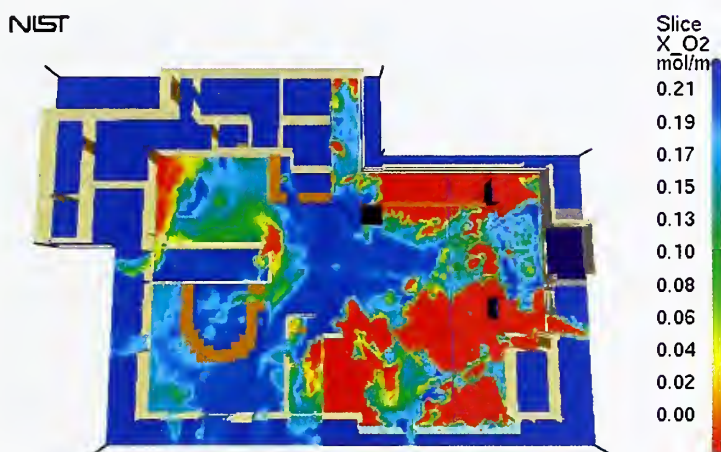
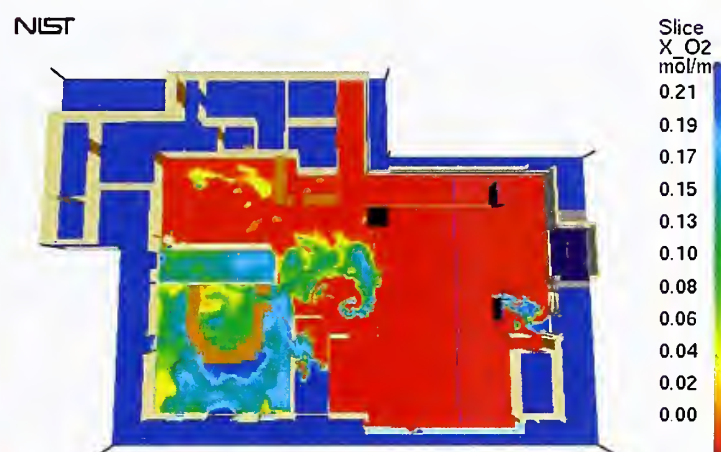
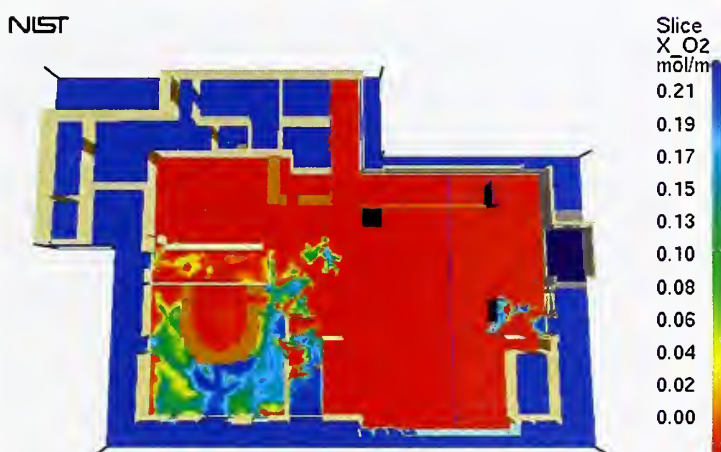
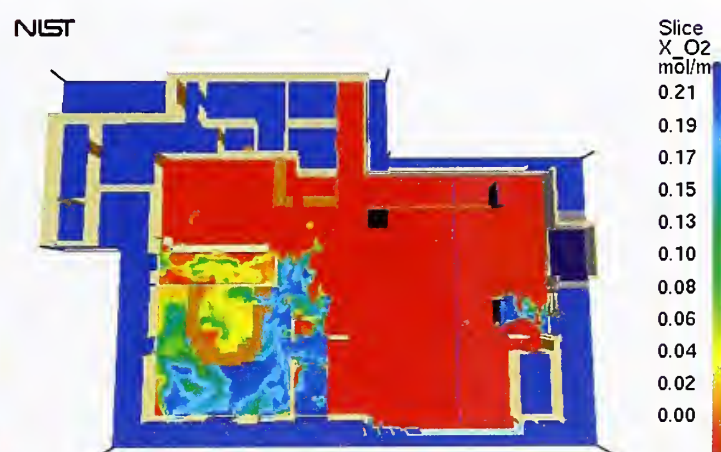
Figure 5-62. Oxygen volume fractions at 0.6 m (2 ft) above the floor, 80 seconds to 250 seconds

Figure 5-62 shows the predicted oxygen volume fraction 0.6 m (2 ft) above the floor, beginning at 80 seconds after ignition through 250 seconds after ignition. At this lower level it is apparent that tenability is also not likely in any area other than the main bar area and the entranceway right inside the front door. The opening of the windows at the front of the main bar room creates a more tenable atmosphere, probably saving the lives of occupants as they can be seen being pulled from the windows in the WPRI video. Occupants that stayed low in the main bar area had a better chance of survival.

The images in later in Figure 5-62, once again, show a rapid decrease in tenable conditions due to oxygen depletion throughout most of the simulated nightclub with the exception of the main bar room and the main entry foyer. Due to the open doors and windows in these areas, the simulation indicates that sufficient fresh air was drawn in to maintain a level of tenability with respect to oxygen in the areas adjacent to the open windows and the main entry way. This trend is shown to continue through the end of the simulation. In the WPRI video, the last person recorded being assisted through a window from the main bar room occurs at 250 seconds after ignition. This is consistent with the predicted oxygen concentrations near the windows.

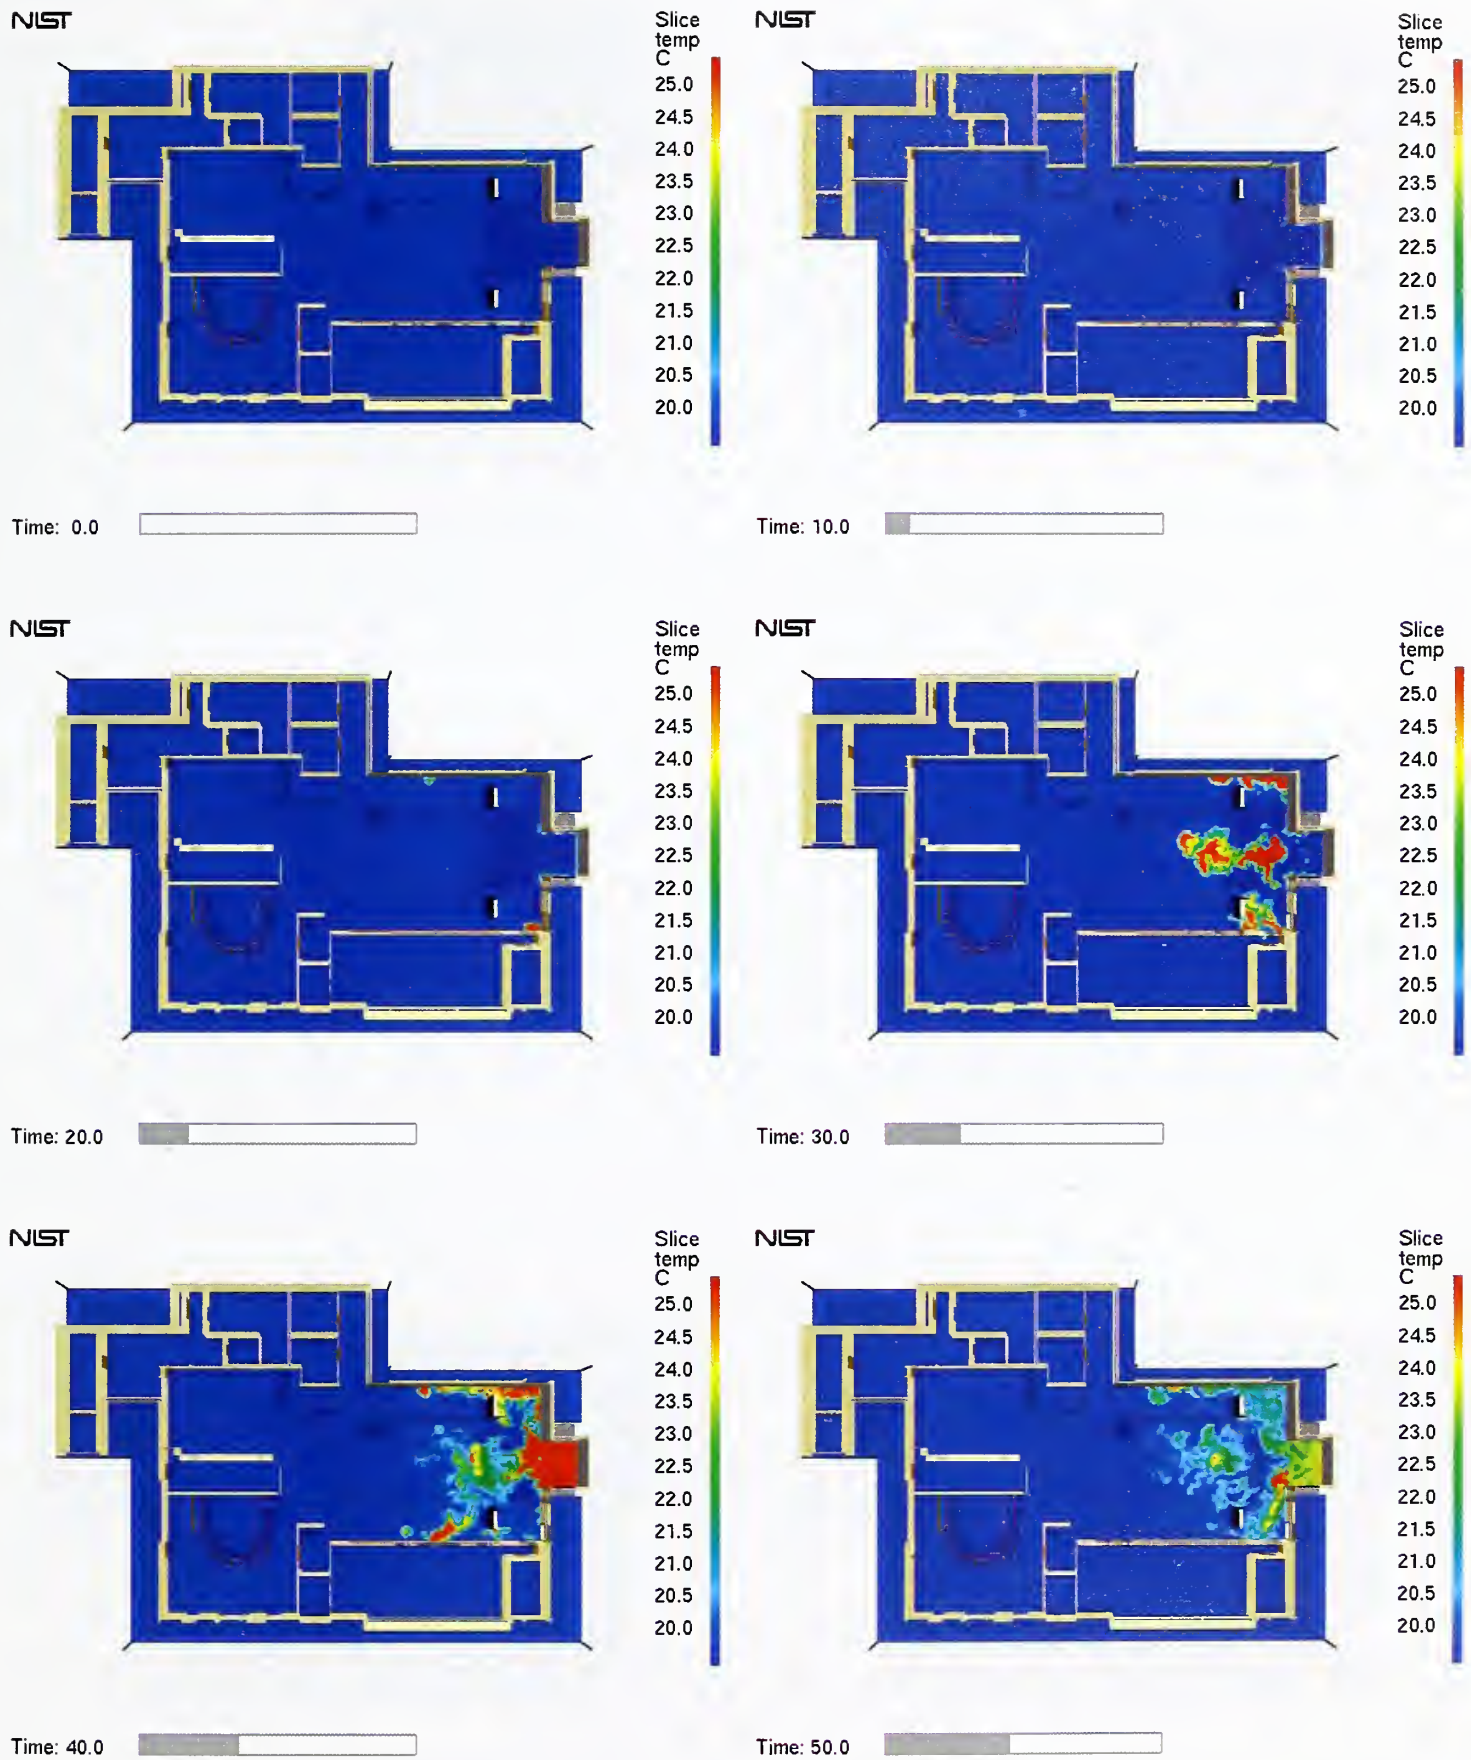
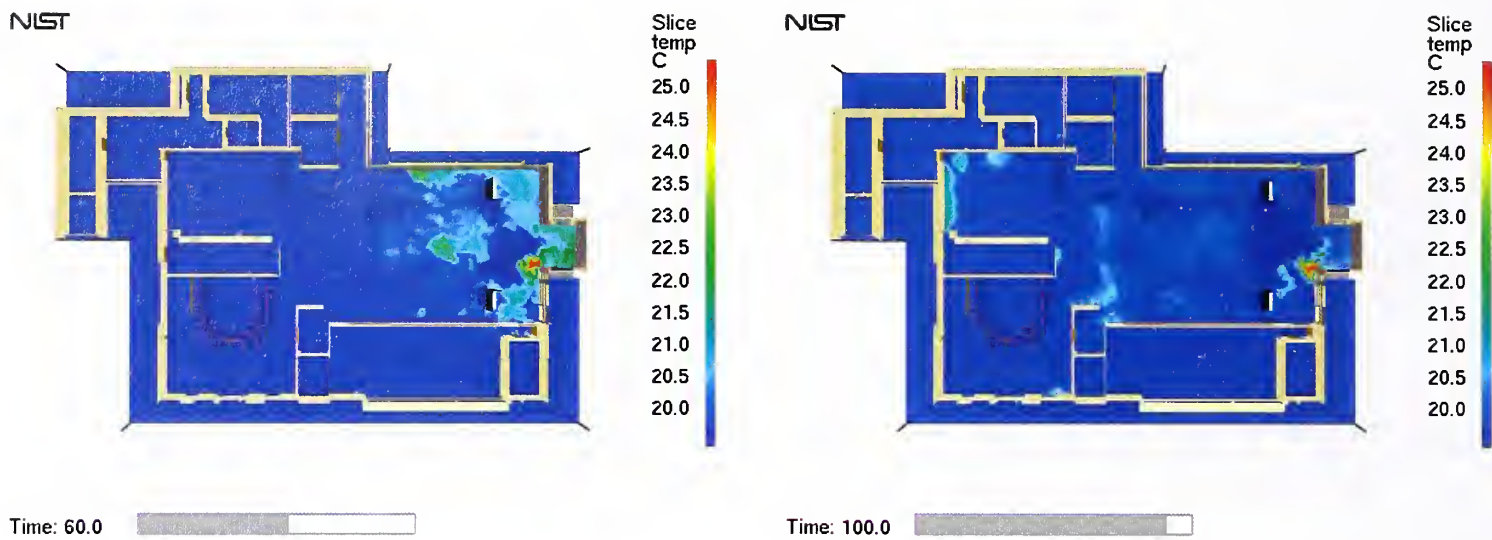
Figure 5-66a. Temperatures at 1.5 m (5 ft) above the floor, 0 seconds to 50 seconds

Isothermal plots are shown in Figures 5-66a and 5-66b to assess the tenability conditions based on temperatures that were predicted during the simulation of the fire. The figures show horizontal isothermal images 1.5 m (5 ft) above the floor from the time of ignition ($t = 0$) to 100 seconds at 10 second intervals, and an image at 150 seconds. Due to the rapid activation of the sprinklers (three sprinklers were operating by 30 seconds after ignition), the temperatures at the 1.5 m (5 ft) level remain well below the temperature tenability threshold of 120 °C (248 °F) [6].

The comparison between the temperatures 1.5 m (5 ft) above the floor in the non-sprinklered simulation (Figure 5-55) and in the sprinklered configuration (Figs. 5-66a and 5-66b) show dramatically different thermal conditions. (Note the large difference in color scales.) During the non-sprinklered simulation temperatures exceeded 1000 °C (1830 °F) in the platform and dance floor areas, and in the main bar room they exceeded 500 °C (930 °F) within 100 seconds. In the sprinklered simulation, the temperature exceeds 25 °C at head height only near the platform; following sprinkler activation around 20 seconds, the thermal environment remains close to ambient up until the time the fire is fully extinguished at 120 seconds.

Given the limited fire spread and the resulting tenable gas temperatures, the heat flux tenability criteria was never exceeded in the sprinklered case.

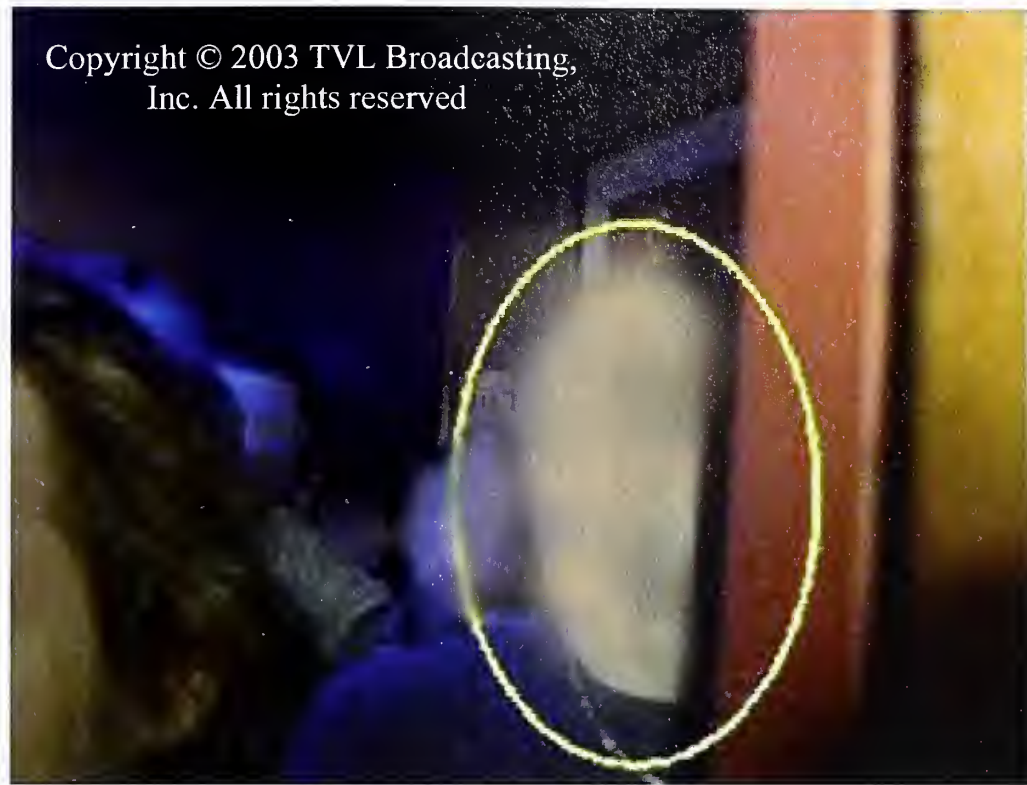
Figure 6-4 Occupant Attempting to Evacuate [2]

Forty-one seconds elapsed between Figure 6-4 (0:01:02 fire time) and when the occupant was first seen near the bottom of the pile. Because the camera operator moved to the side of the building immediately upon exiting through the main exit, it is not known when the individual shown in these figures reached the door and fell to that position.

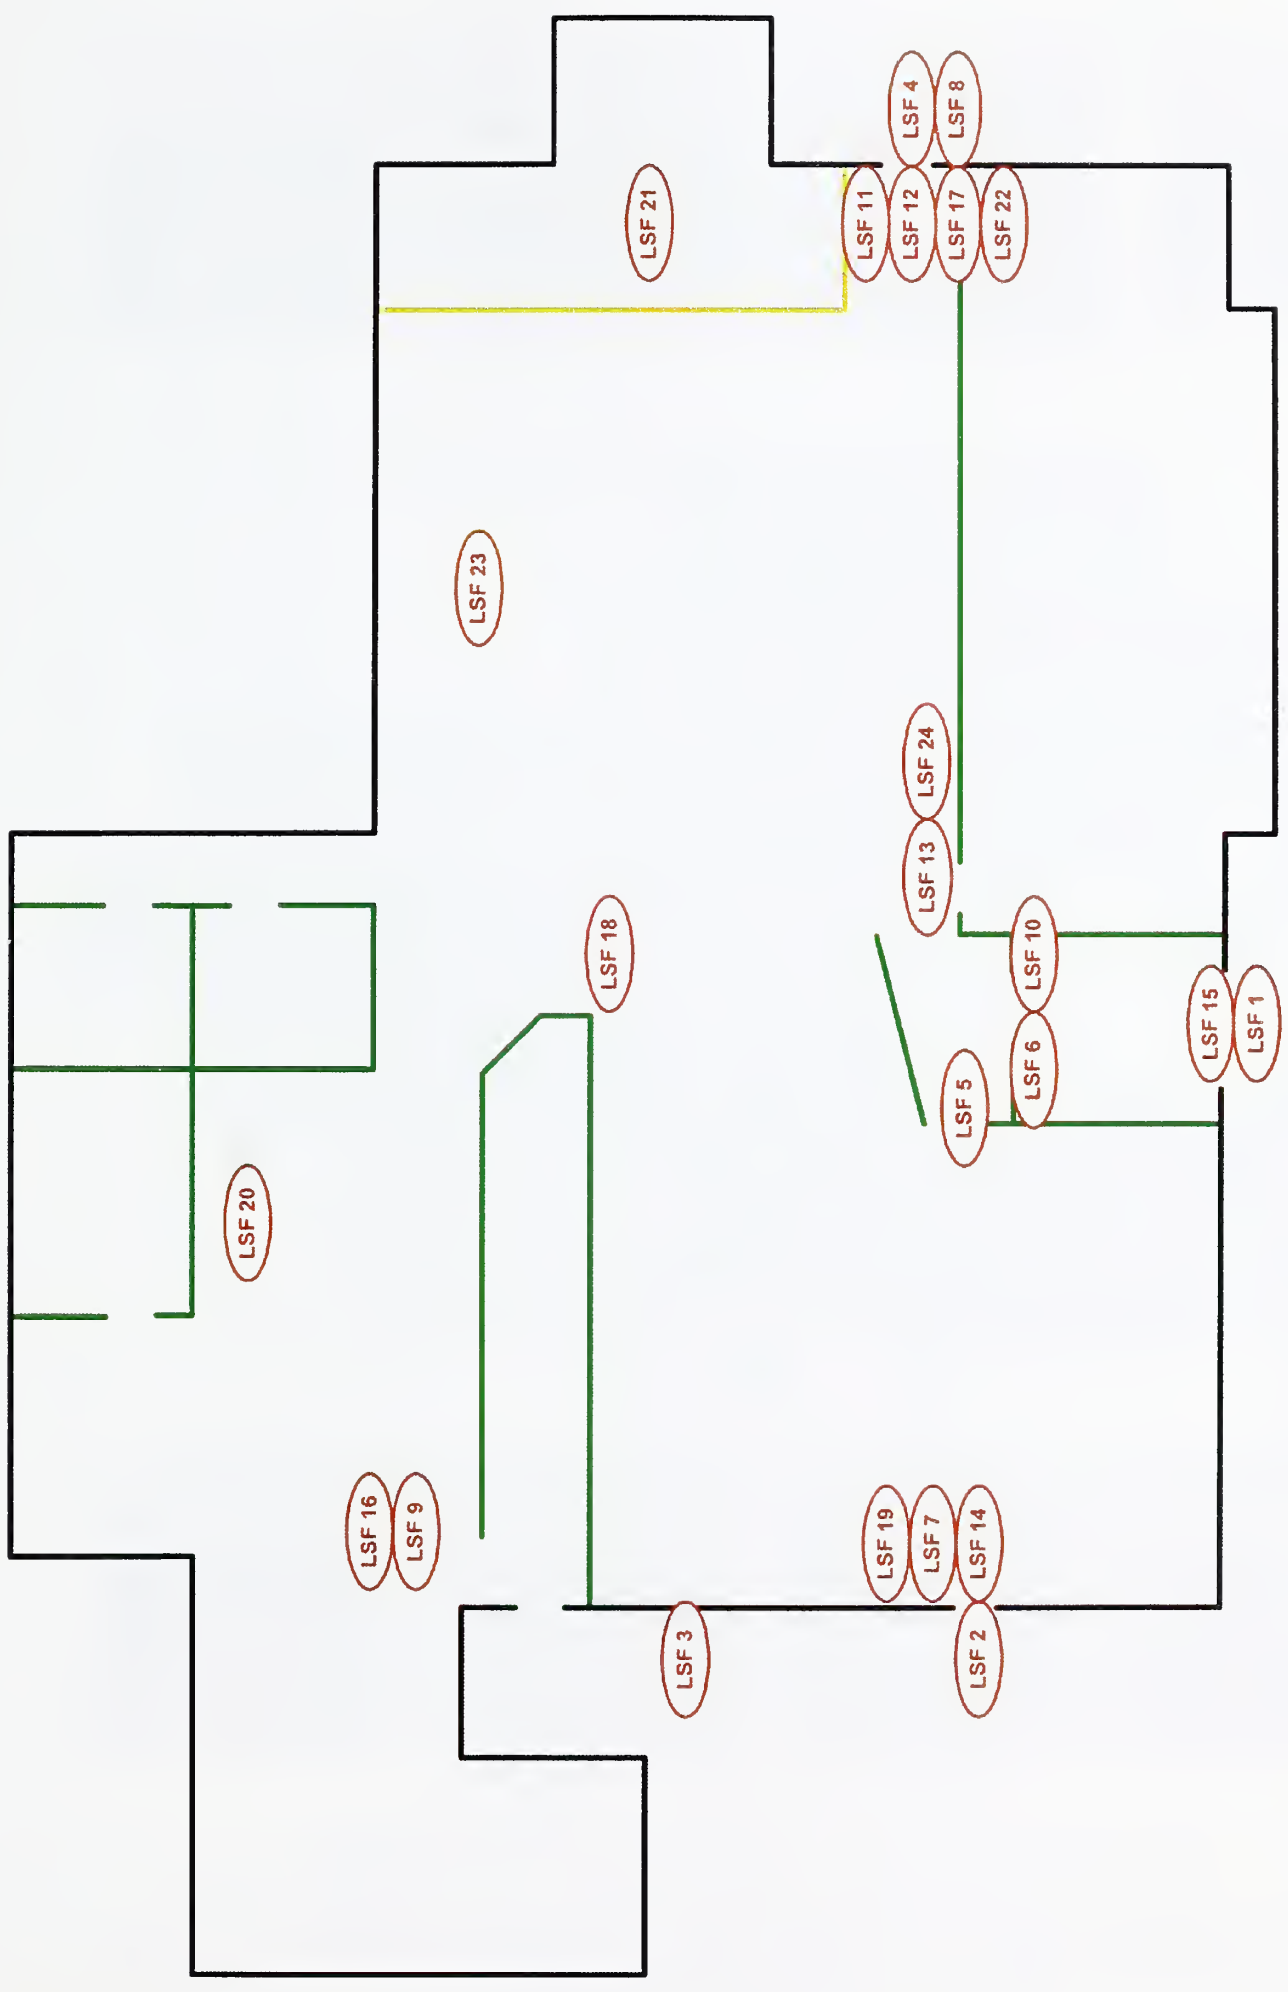
Figure 6-9. Locations of life safety features listed in Table 6-1.

Table 6-1 summarizes all identified life safety features within The Station prior to the fire. Refer to Figure 6-9 for the locations of these features within the building. Specific devices and features are shown in Figures 6-10 and 6-11, taken from video stills or photographs taken at the site on Feb. 22, 2003. (Large format copies of the photos are included in Appendix B.) Additional details, such as manufacturer names, model numbers, or other descriptions of the devices were not available.
